ADAPTATION ATLAS – Coastal Case Study: Australia and NZ East Coast storm resilience

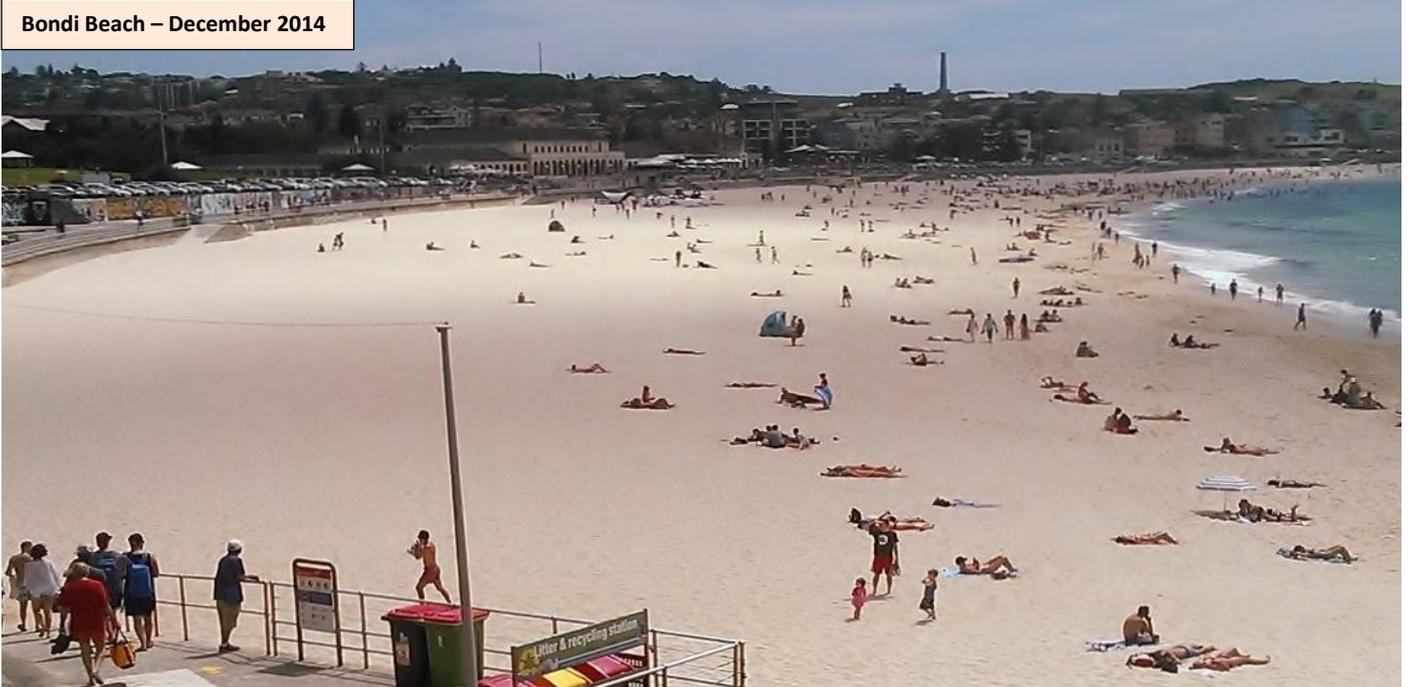
Bondi Beach – December 2014

Lots of fun, sun, sea, sand – but also a total lack of beach stabilising beach vegetation

But does the complete lack of beach vegetation shown above really matter? Maybe locals insist there isn't sufficient space for plants on their beach? Why bother re-establishing the original and indigenous vegetation when these plants might just be a nuisance and get in the way...??

Note: The first in this series of photos reveals that Bondi Beach is completely devoid of natural beach and dune vegetation. These storm photos very clearly illustrate that huge volumes of sand were readily moved by the storm winds, blown up and over the back-beach seawall plus fences, and rapidly relocated inland. This vital sediment is now lost forever from this beach compartment. And this is only one storm in one year.

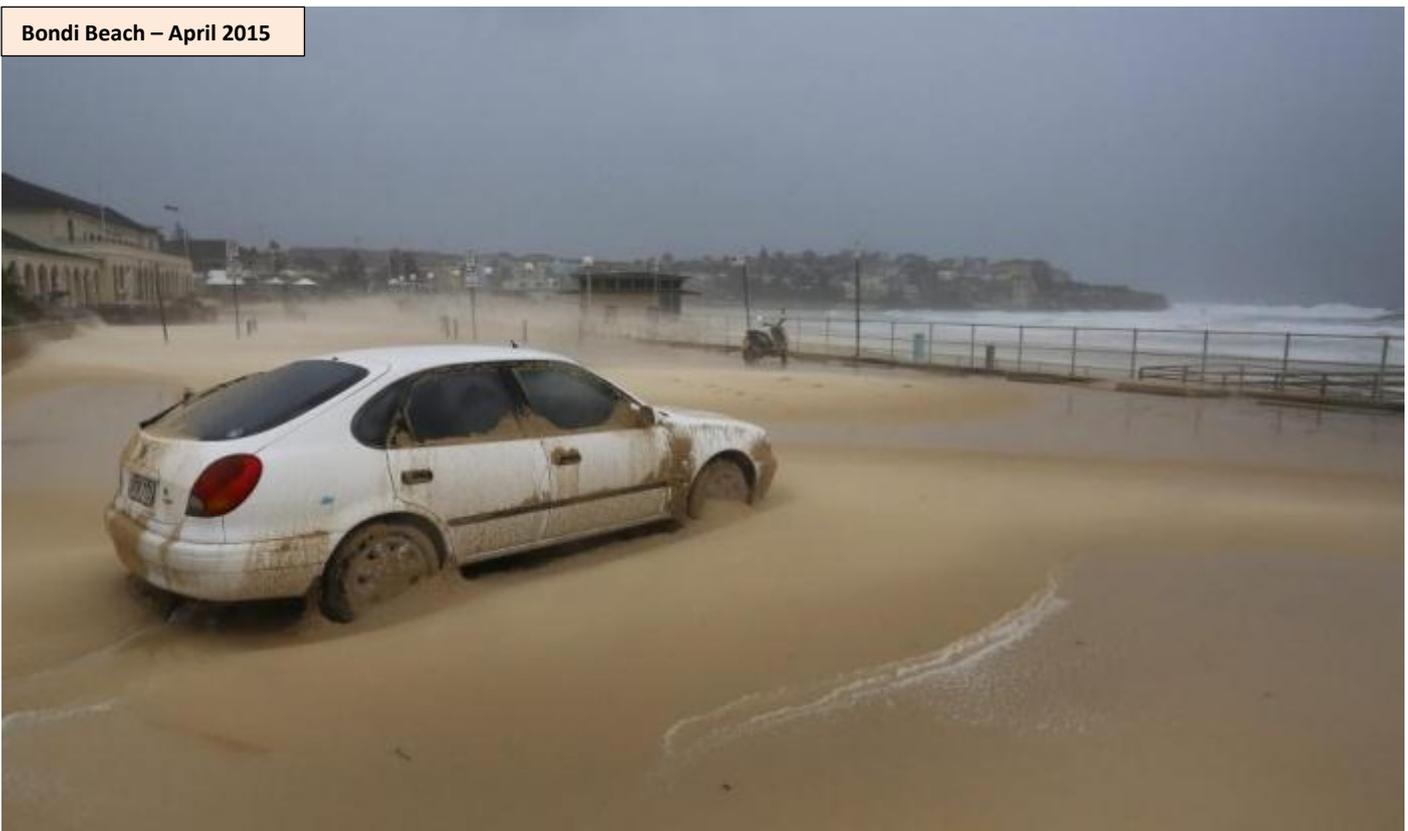
Bondi Beach – April 2015

From The Sydney Morning Herald 22 April 2015: “The destructive winds, which topped 130km/h, dumped blankets of sand from Sydney's beaches onto nearby streets and carparks.”

Bondi Beach sand storm 21 April – above and below (Source – The Guardian Newspaper - Sydney)

This alarming situation impacting on beaches repetitively ensures huge losses of valuable sediment whenever winds reach sufficient velocities to create this natural sand movement (saltation) in those unnatural circumstances, as illustrated by the above photos. All mobile sand was lost due to a lack of beach plants.

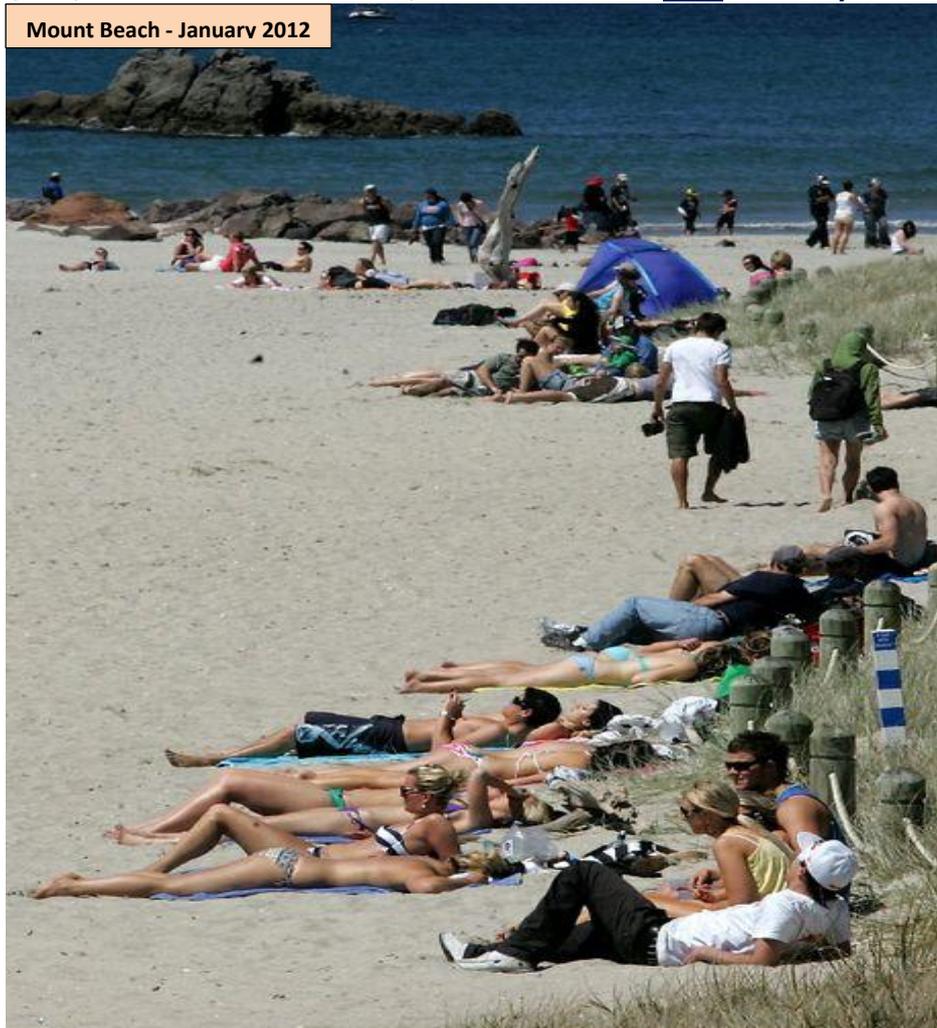
2. Mount Maunganui Beach, NZ – January 2012:

Lots of fun, sun, sea, sand – but now on wide, restored beaches with naturally stabilising vegetation

NOTE: the above beach and vegetated dune is being enjoyed quite thoroughly as a relaxing, recreational paradise. But just as importantly, this beach system is now growing wider due to restorative plantings 10 years prior - in 2002. That fact will ensure this current picturesque situation will remain a certainty for very many future years. This element is being monitored by the striped post near the serene sunbathers.

This restorative planting ensures any mobilised sand is trapped by these new plants. Consequently this beach system has advanced seaward by over 25metres since 2002, including the 6 metres of extra sand accumulated to a depth of +50cm in the 2 year period as shown in the 2012 and the 2014 photos (see the striped sand datum post above and below). The research data collected here reveals an accumulation rate of 3m^3 of fresh sand/lineal metre of beach over those 2 years, or 1.5m^3 of fresh sand/year. And this once-only ethical beach restoration costs less than NZ\$50/lineal metre.

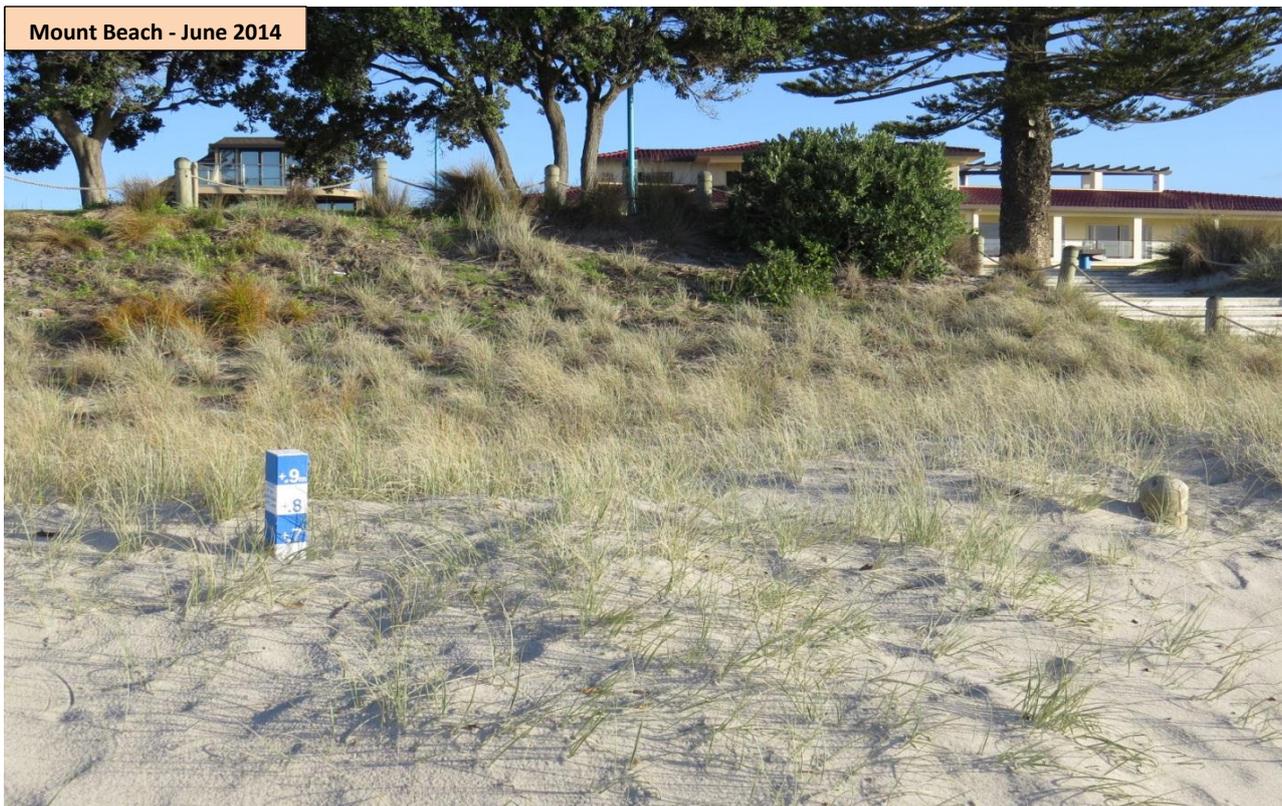
MOUNT MAUNGANUI BEACH JUNE 2014: AT THE SAME LOCATION (BUT DIFFERENT ANGLE) AS THE BOP TIMES PHOTO ABOVE.
